SHATTO DAM  
SULLIVAN COUNTY, MISSOURI  
MO 10068

PHASE 1 INSPECTION REPORT  
NATIONAL DAM SAFETY PROGRAM.

PHASE I REPORT  
NATIONAL DAM SAFETY PROGRAM

Name of Dam	Shatto Dam
State Located	Missouri
County Located	Sullivan County
Stream	Tributary to East Locust Creek
Date of Inspection	July 21, 1978

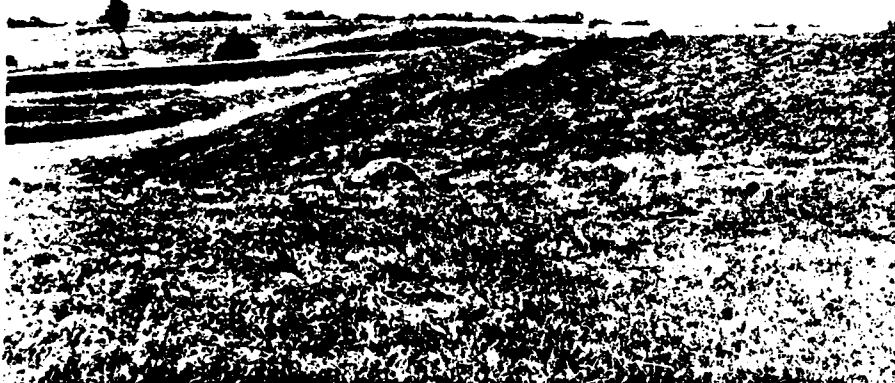
PHOTO. NO. 3  
DOWNSTREAM SLOPE  
TAKEN FROM NORTH  
LOOKING SOUTH

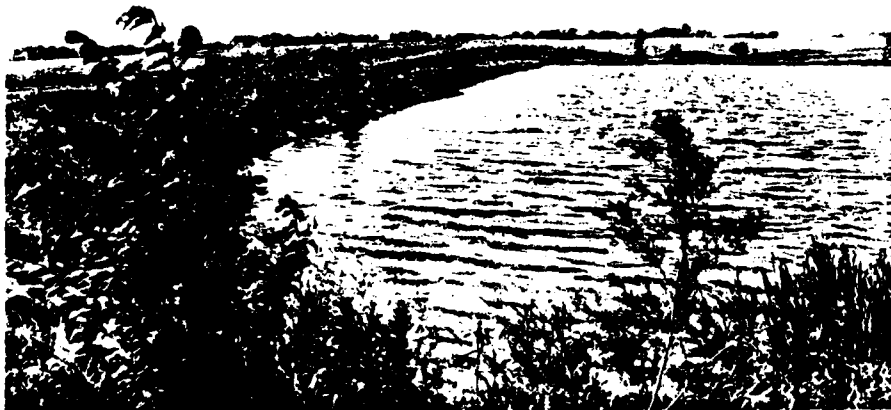
b. Dam. The riprap on the upstream face consists of durable limestone and looks good. There was no evidence of significant erosion or slips on the upstream slope. A couple of elm saplings, near the waterline, were observed toward the left (north) end of the dam. Some small willows were also observed around the principal spillway inlet area.

PHOTO. NO. 4  
UPSTREAM SLOPE  
TAKEN FROM NORTH  
LOOKING SOUTH

a. Safety. The few small trees on the upstream face of the dam should be removed. Additional studies should be made to determine the source and affects on structural stability of seepage conditions observed on the downstream slope and toe of the dam. The probable maximum flood will overtop the dam. The spillways will pass the 0.36 PMF without overtopping.

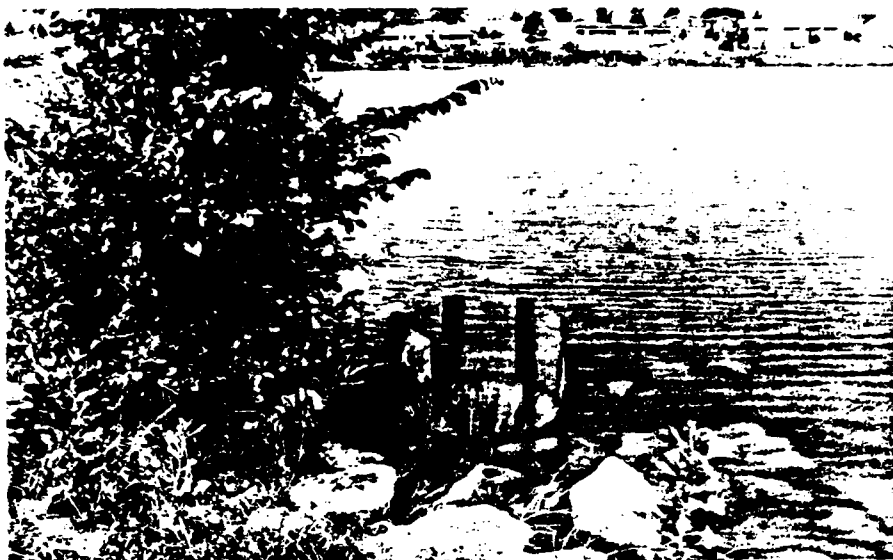
- (11) Foundation/Embankment Drains - no.
- h. Diversion and Regulating Tunnel. None.
- i. Spillway.
- (1) Principal
    - (a) Type - 48 diameter corrugated metal pipe inlet riser (See Photo No. 5) with wire mesh screen on crest and a 12 inch corrugated metal pipe conduit.

c. Appurtenant Structures. The principal spillway consists of a corrugated metal pipe riser, 4 feet in diameter and 4 feet in height, connected to a 12 inch diameter CMP outlet passing through the dam. The inlet pipe is covered with wire mesh. The outlet discharges into the natural drainageway about 1200 feet downstream from the dam (see plan view in Appendix C). Water to a depth of about 2 inches was flowing over the crest of the spillway at the time of the inspection. There was no visual evidence of deterioration of the principal spillway.

PHOTO. NO. 5  
48" DIAMETER CMP  
SPILLWAY ENTRANCE

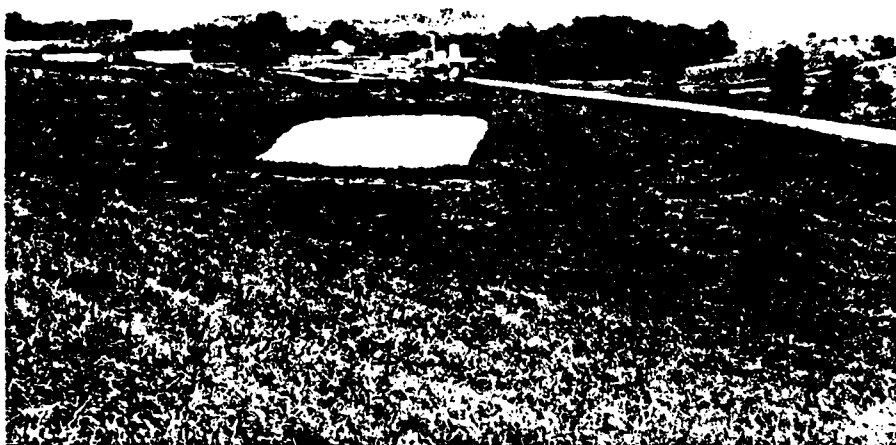
PHOTO. NO. 6  
FORMER SEWAGE  
LAGOON DOWNSTREAM  
FROM DAM. PHOTO.  
TAKEN FROM SOUTH  
END OF DAM.

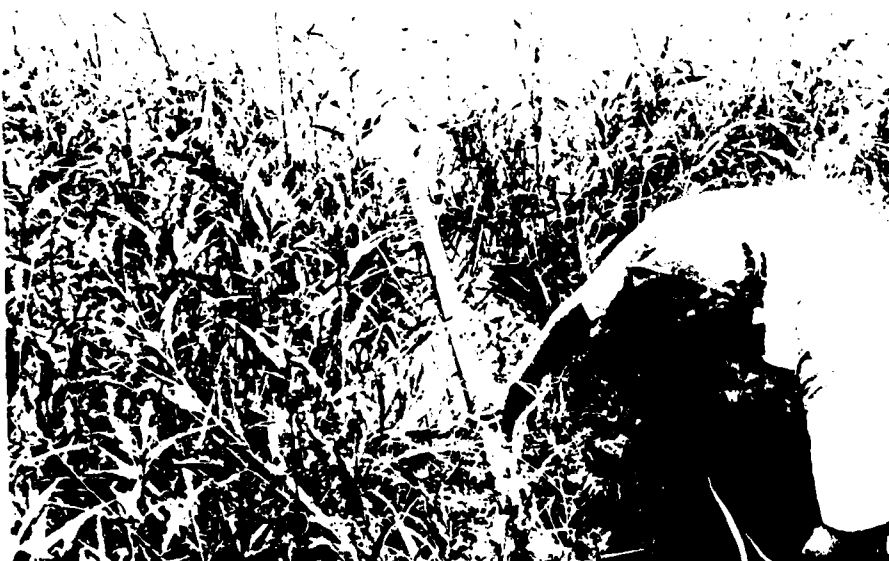
d. Post Construction Changes. The discharge from a natural spring in the south (right) abutment was intercepted and controlled and the slip on the downstream slope of the dam caused by the uncontrolled seepage from spring was repaired a couple of years after the dam was constructed.

PHOTO. NO. 7  
DRAINAGE OUTLET  
FOR SPRING - SOUTH  
ABUTMENT

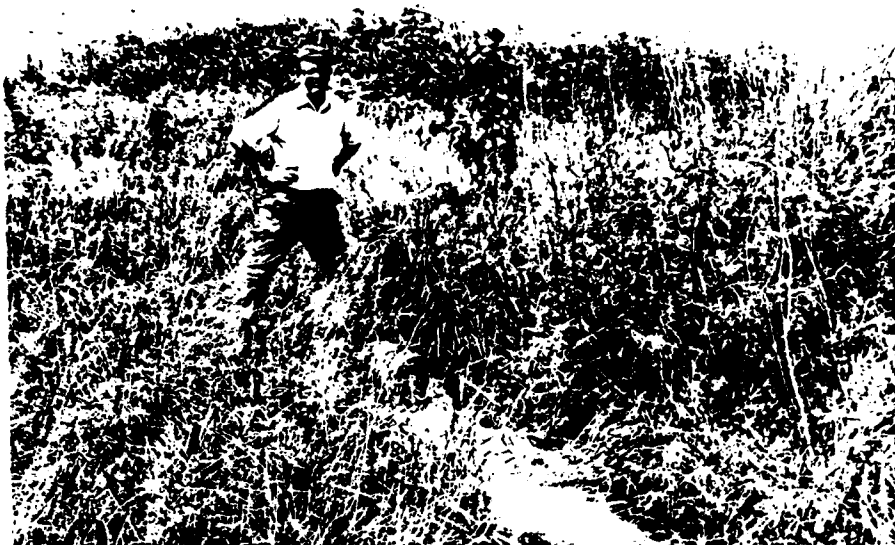
e. Downstream Channel. The principal spillway discharges through a pipe into the natural drainageway some 1200 feet below the dam. No operational problems were noted at the outlet of this spillway. The emergency spillway discharges into an adjacent watershed over the hill that forms the north abutment of the dam.

PHOTO. NO. 8  
PRINCIPAL SPILLWAY  
OUTLET

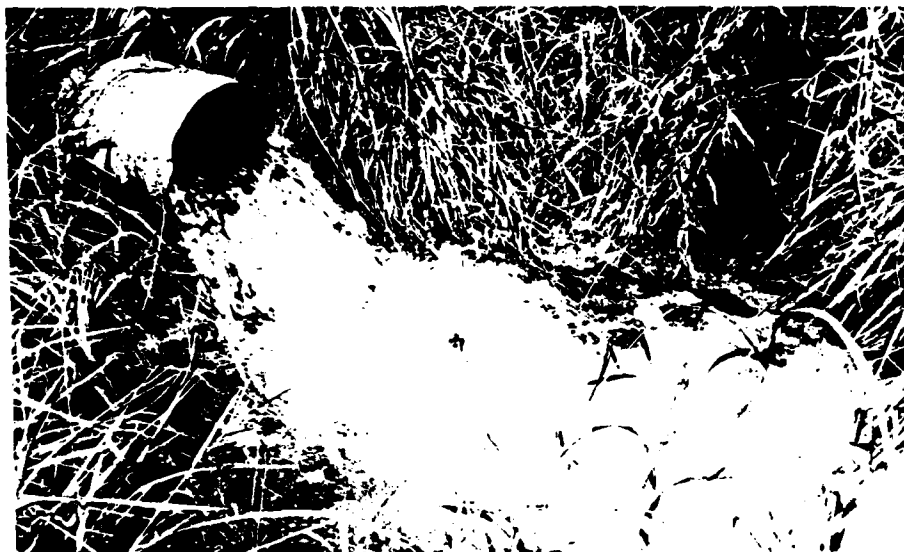
PHOTO. NO. 9  
PRINCIPAL SPILLWAY  
OUTLET

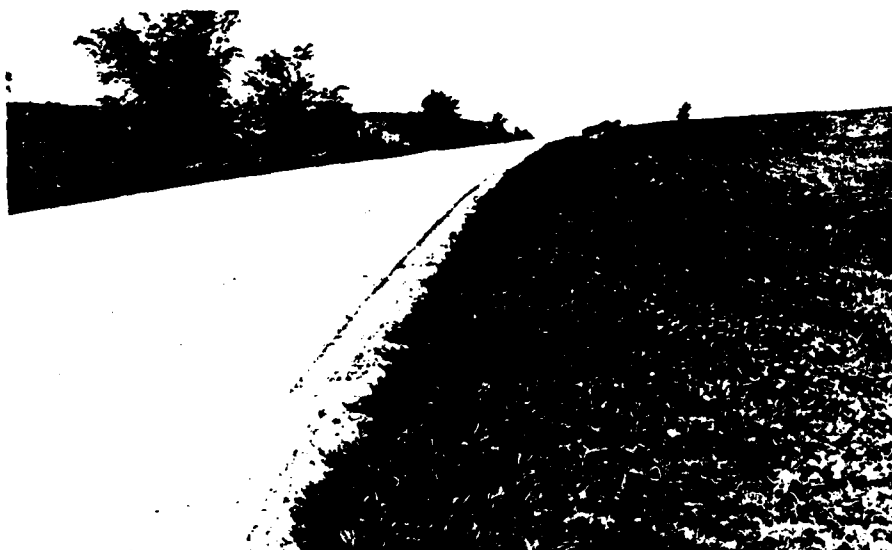
PHOTO. NO. 10  
DOWNSTREAM SLOPE  
TAKEN FROM HIGHWAY  
LOOKING NORTHWEST

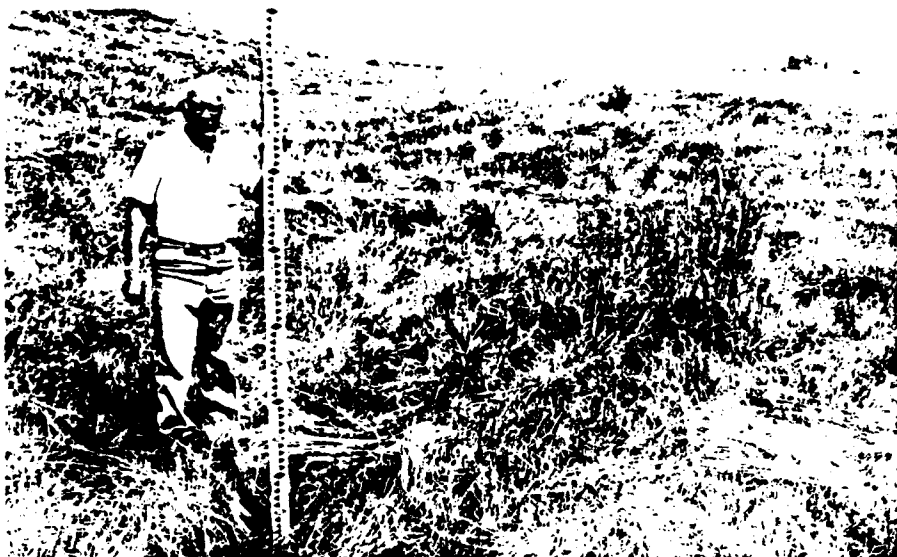
Abutments for the dam consist of glacial till which apparently overlies limestone (stone was quarried in the bottom of the valley which now comprises a portion of the reservoir bottom). No slides were evident in the abutments. A seepy area was observed in the left (north) abutment adjacent to the embankment-abutment through about halfway between the crest and the toe of the dam. No boils were observed and the discharge from this seep area was clear. Discharge was estimated to be  $0.1 \pm$  gal/min. This seep could be the result of a natural spring in the left abutment as discovered and remedied on the right abutment.

PHOTO. NO. 14  
SEEP AREA ON  
NORTH ABUTMENT

d. Necessity for Phase II. Phase II investigation is not called for. Additional engineering data should be obtained, at the owner's expense, to determine the source of the seepage water observed on the downstream slope and toe of the dam and the possible affects that the seepage may have upon the structural stability of the dam. The engineering investigations should be done by a professional engineer who is experienced and competent in earth dam design.

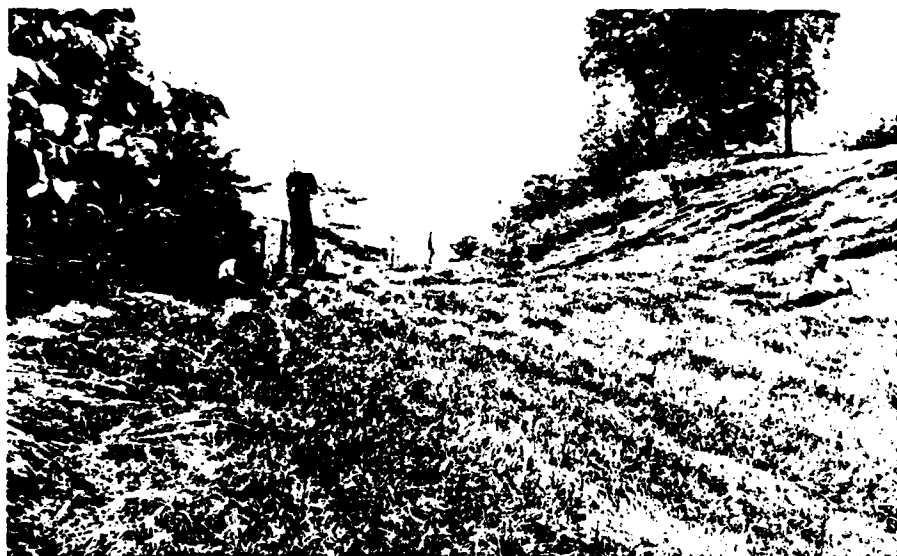
An old railroad cut is utilized as an emergency spillway (see Appendix C). The spillway crest is about 34 feet from the shoreline of the lake. It has an elevation of  $889.5 \pm$  feet and a bottom width of  $33 \pm$  feet. The outlet channel has a bottom width of  $26 \pm$  feet and side slopes of 2.1 to 2.5 H on 1V. The emergency spillway is well grassed and maintained. No obstructions, slides, or deformations were noted in the spillway.

PHOTO. NO. 15  
LOOKING UPSTREAM  
IN EMERGENCY  
SPILLWAY

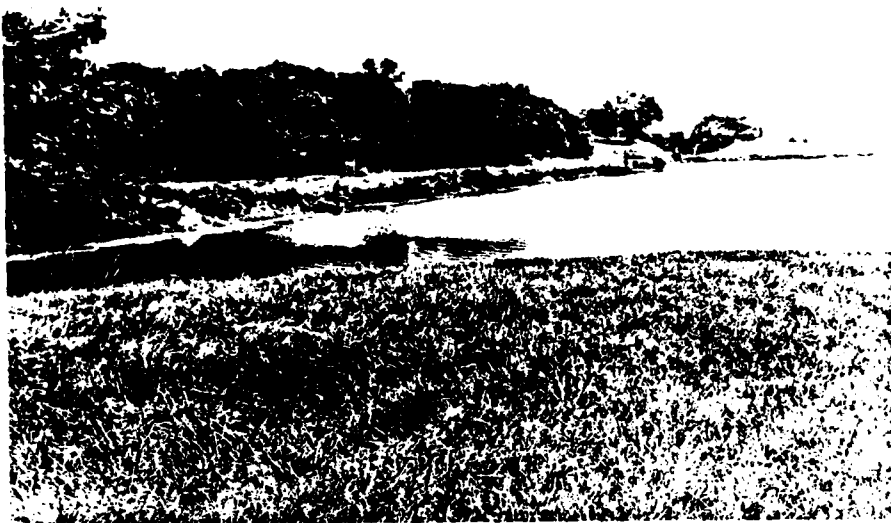
PHOTO. NO. 17  
OLD RAILROAD  
GRADE TAKEN  
FROM WEST

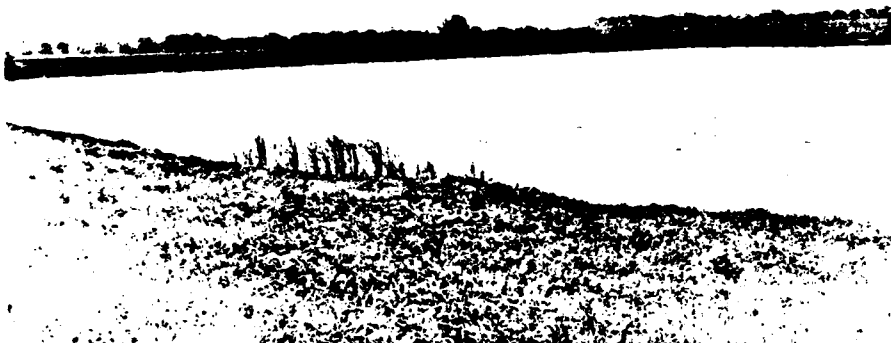
PHOTO. NO. 18  
UPSTREAM FACE OF  
DAM LOOKING SOUTH-  
EAST

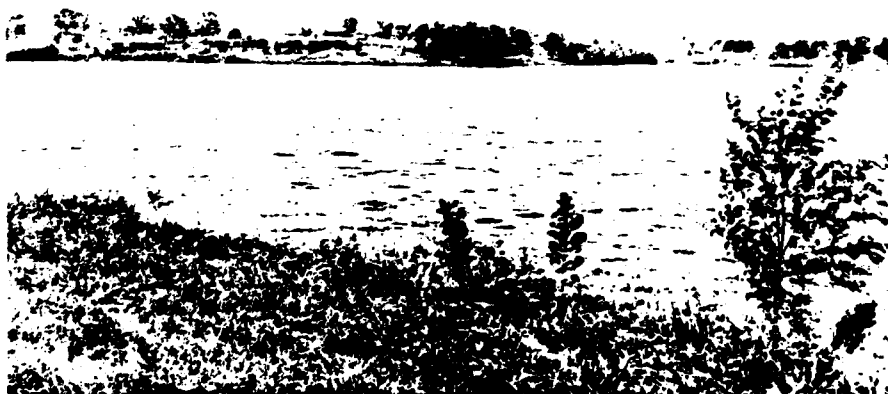
PHOTO. NO. 19  
LOOKING UPSTREAM  
FROM CENTER LINE  
OF DAM
